Flood Recovery in Webbers Falls, Oklahoma:

A FEMA and DWSRF Funding Success

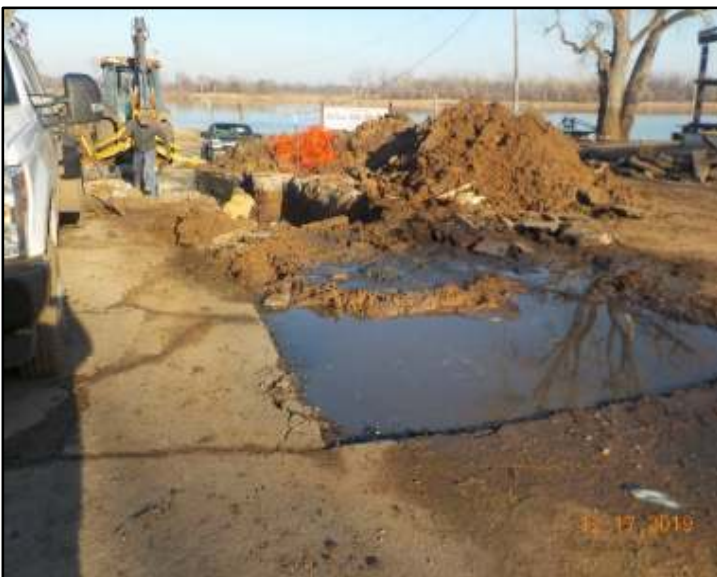
Due to a major flooding event in May 2019, the Webbers Falls community had a mandatory emergency evacuation and ECOWA closed the water valves. When the flood waters receded and residents returned, ECOWA opened the water valves but residents on the west side of the river were not receiving drinking water. Upon investigation, they discovered that the 6-inch water line that was supposed to be located on the bottom of the river bed had washed away in the flood.
